Research Article

## The Restoration of the Nymphaeum of Trajanus in Miletus between Formal Renovation and Structural Repair

Giacomo CASA\*

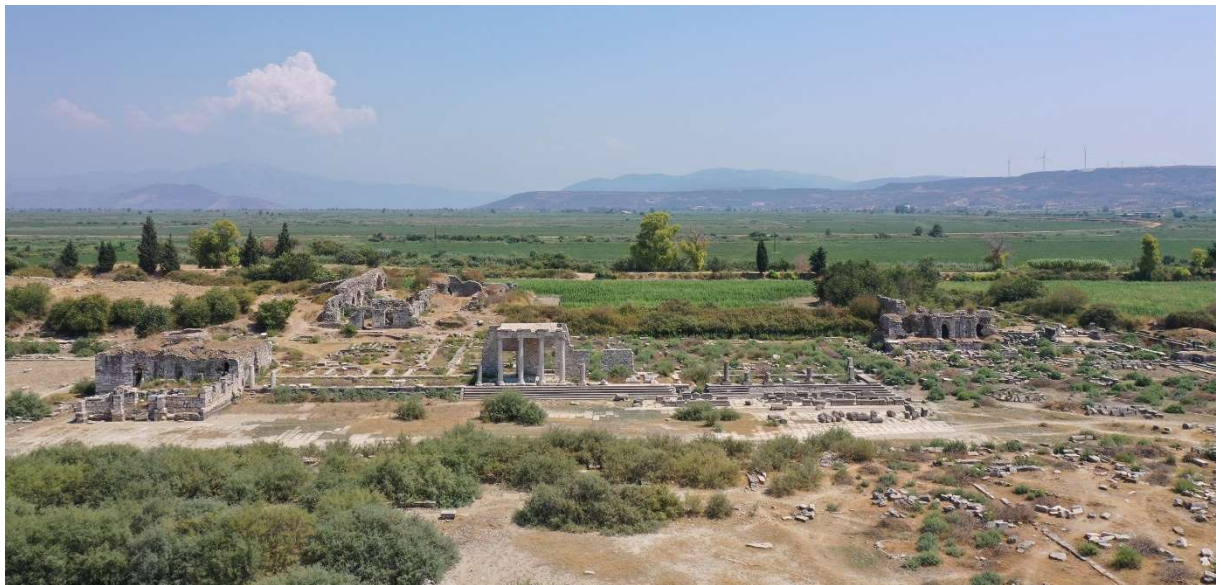
Figure 1: Aerial photo of the Agora of Miletus (*archive of the German Archaeological Mission of Miletus*)

This paper is part of a broader re-examination of the restoration works carried out on the public buildings surrounding the Agora of Miletus (fig. 1). Despite they have all been extensively investigated and studied in monographic and comprehensive studies – such as the Delphinion<sup>4</sup>, the Bouleuterion<sup>5</sup>, the Nymphaeum of Traianus the Elder<sup>6</sup>, and the Market Gate<sup>7</sup> – the central aspect of architectural restoration has been only marginally addressed in

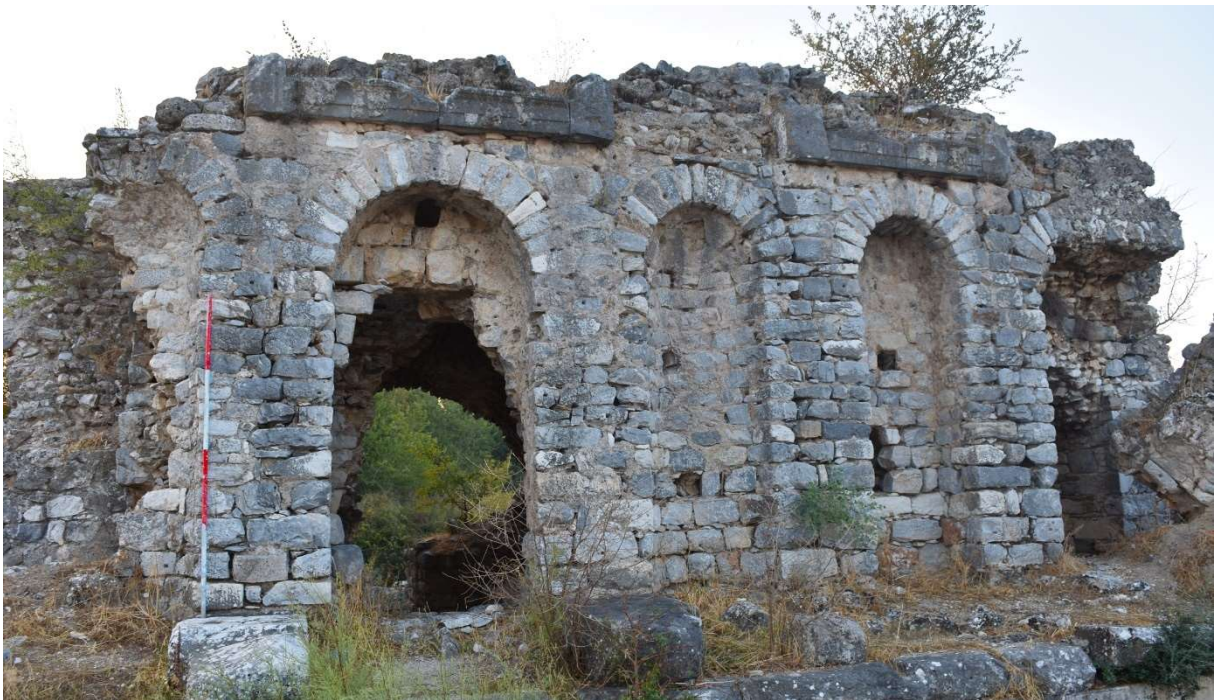
Figure 2: Façade of the Nymphaeum of Traianus (*archive of the German Archaeological Mission of Miletus*)

The fountain belongs to the type of rectilinear nymphaea with an imposing *Tabernakelfassade*<sup>10</sup> (20.25 m) consisting of three storeys of Corinthian order, decorated with aediculae framing nine alternating rectangular and semicircular statuary niches per storey (fig. 3). The building is provided of two storeyed and projecting lateral wings, lower than the façade and without a rear wall, enclosing a large rectangular pool for water collection. The pool, which used to feed two latrines on each side of the fountain, is defined, toward the street, by a high balustrade, in front of which a second, lower basin is located for water supply. In the façade, the aediculae, formed by pairs of reddish-yellow marble columns supporting a white marble entablature, are arranged in a staggered and non-axial layout between the three storeys, and are crowned on the second and third levels by triangular and double-voluted pediments. The statuary programme hosted in the niches includes marble images of deities from the city’s *pantheon*, personifications and subjects closely linked to the aquatic world, now housed in the museums of Izmir, Istanbul, and Berlin<sup>11</sup>.

The back wall of the façade and the perimeter walls are constructed using small ashlar blocks arranged in regular horizontal courses and laid in a stratified pattern, with larger elements employed in the lower sections and progressively smaller blocks in the upper levels. Behind the façade, three rooms, each covered with vaulted roof composed of irregular limestone blocks mixed with marble fragments and bricks, served as substructures for the two upper cisterns, where the water conveyed by the aqueduct located behind the fountain flowed through. Here, the water was redistributed and channelled toward the basins through a complex system of longitudinal and transversal terracotta pipes, meticulously reconstructed by Ch. Hülsen<sup>12</sup>.

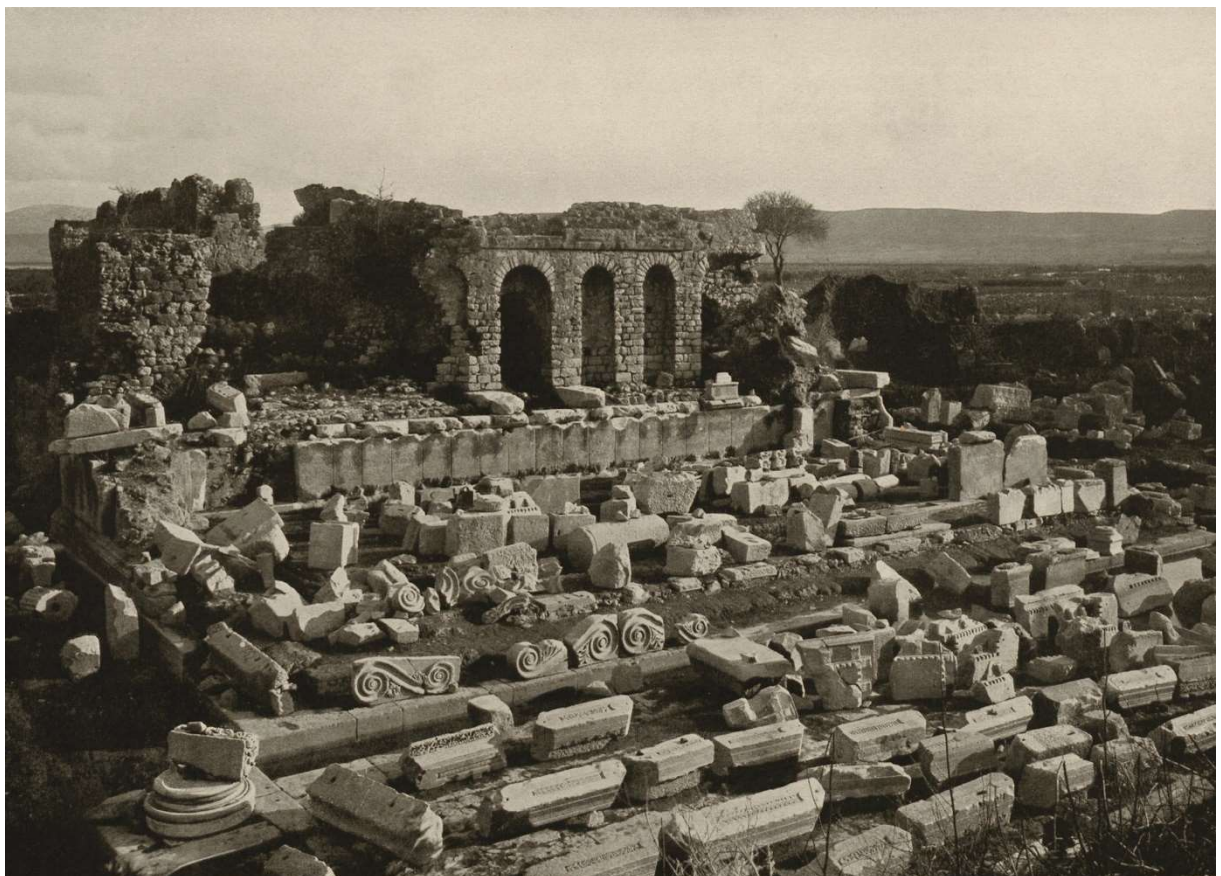
Figure 5: Archival photos of the Nymphaeum of Trajanus after the excavation (after Hülsen 1919, pl. 1)
